# Modular Gabion Systems

## Project

Patrick Air Force Base, Florida

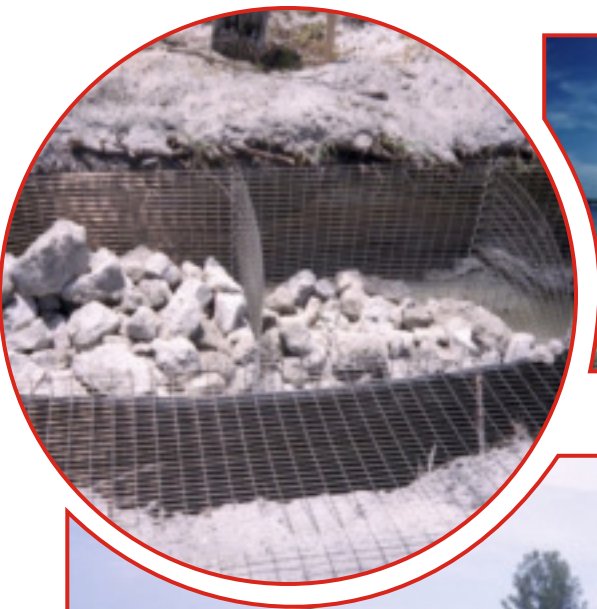
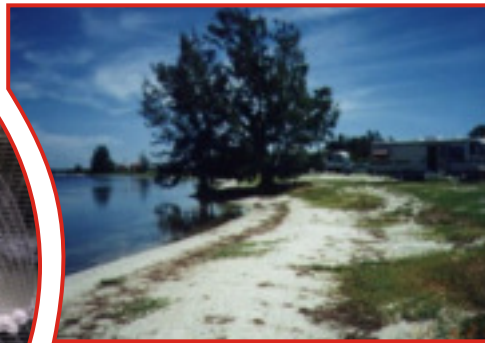
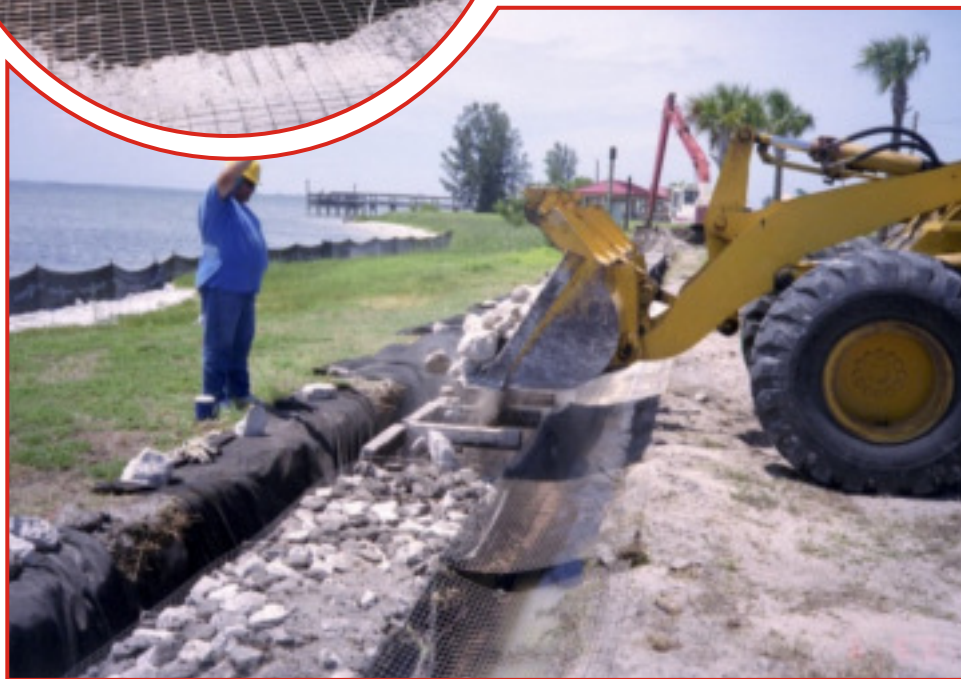
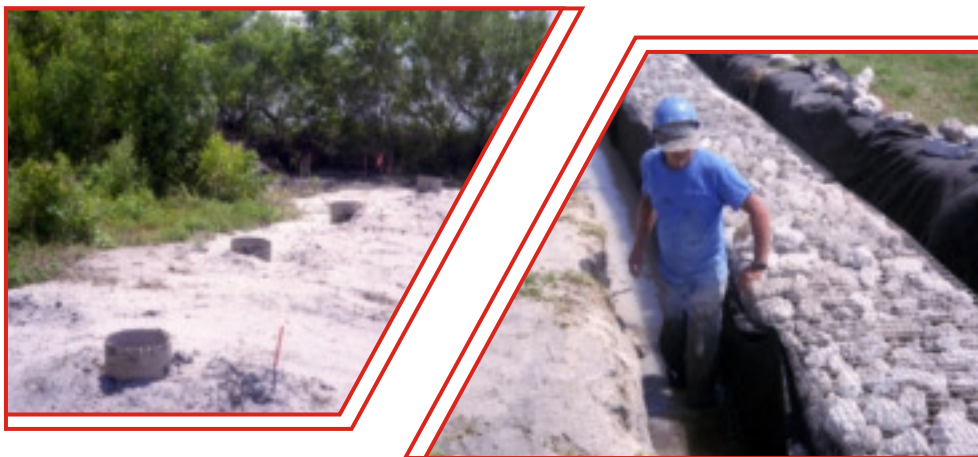
To accomplish this, a row of stainless steel Modular Gabion Systems gabion baskets was buried below the existing grade parallel to the shoreline, landward of an established wetlands. The installation site was prefitted with filter fabric, gabion baskets were placed and filled with locally quarried Coquina stone. The lids of the baskets were then closed and the void spaces between the stone were filled with sand. An additional layer of sand, six inches thick, was placed over the gabions. Red and Black mangrove trees were then planted on top of and seaward of the gabion structure in biodegradable cardboard tubes, and the remaining disturbed areas were seeded.

Burying the gabions allows the beach to retain its natural appearance. The baskets will not normally be seen yet still provide erosion protection for the estuary. In a severe storm event, the gabions will protect the beach and the upland in two ways. First, if overtopped, the gabions will act as a retaining wall, preventing soil from behind the gabion structure from washing into the river. Second, if a storm event causes erosion of the frontal beach, the gabion structure will absorb the energy from the storm waves, thereby impeding beach loss. It is possible that this gabion basket system could be exposed during storm events. However, once the wave action subsides, naturally-occurring sand deposition will restore much of the last sand.

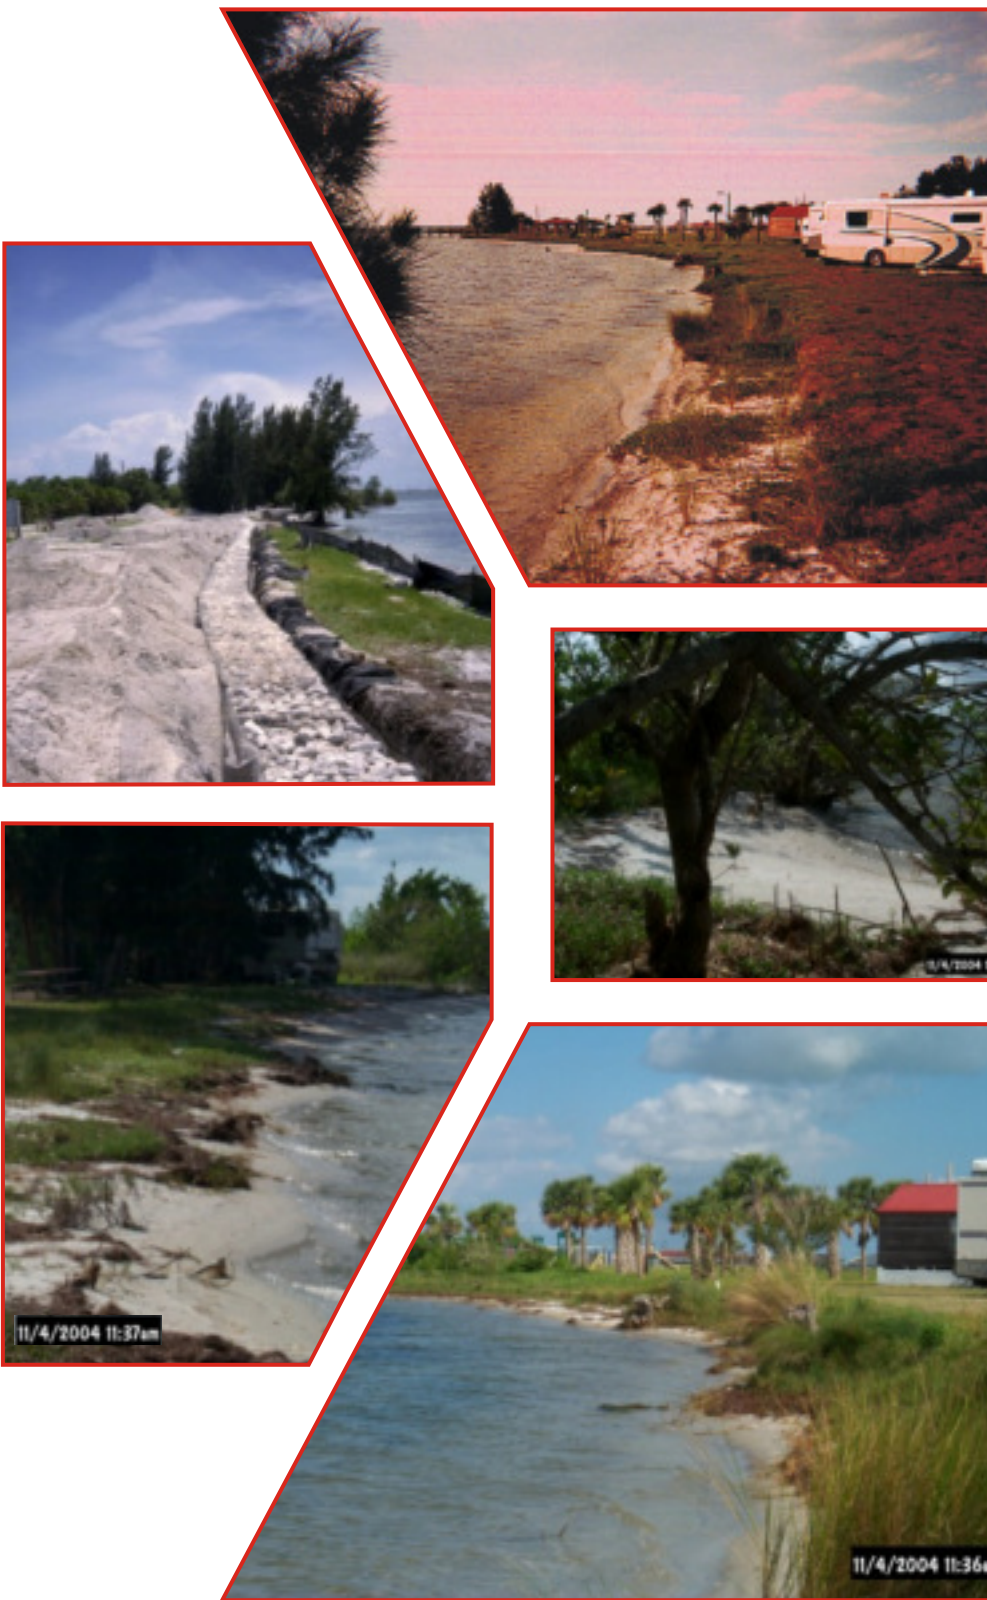
Compare the photos at top left (construction phase, 2001) and top right (pre-construction, 2001) with the photos at bottom left and bottom right taken from similar vantage points on November 11, 2004 following the hurricanes. The photo mid-right shows the established mangrove trees.

In the aftermath of these storms, all the beaches in the area were closed and were to remain so until the following May. In November however, just weeks after the storms, the beaches at Patrick AFB had regained 3-feet of sand and were reopened.
